Copper Theft: Problem, Testing, Solution

AT&T partnered with security company SNC in an effort to halt the theft of copper from the wireless carrier's cell sites in its North Texas operating area.

by Keith Jentoft

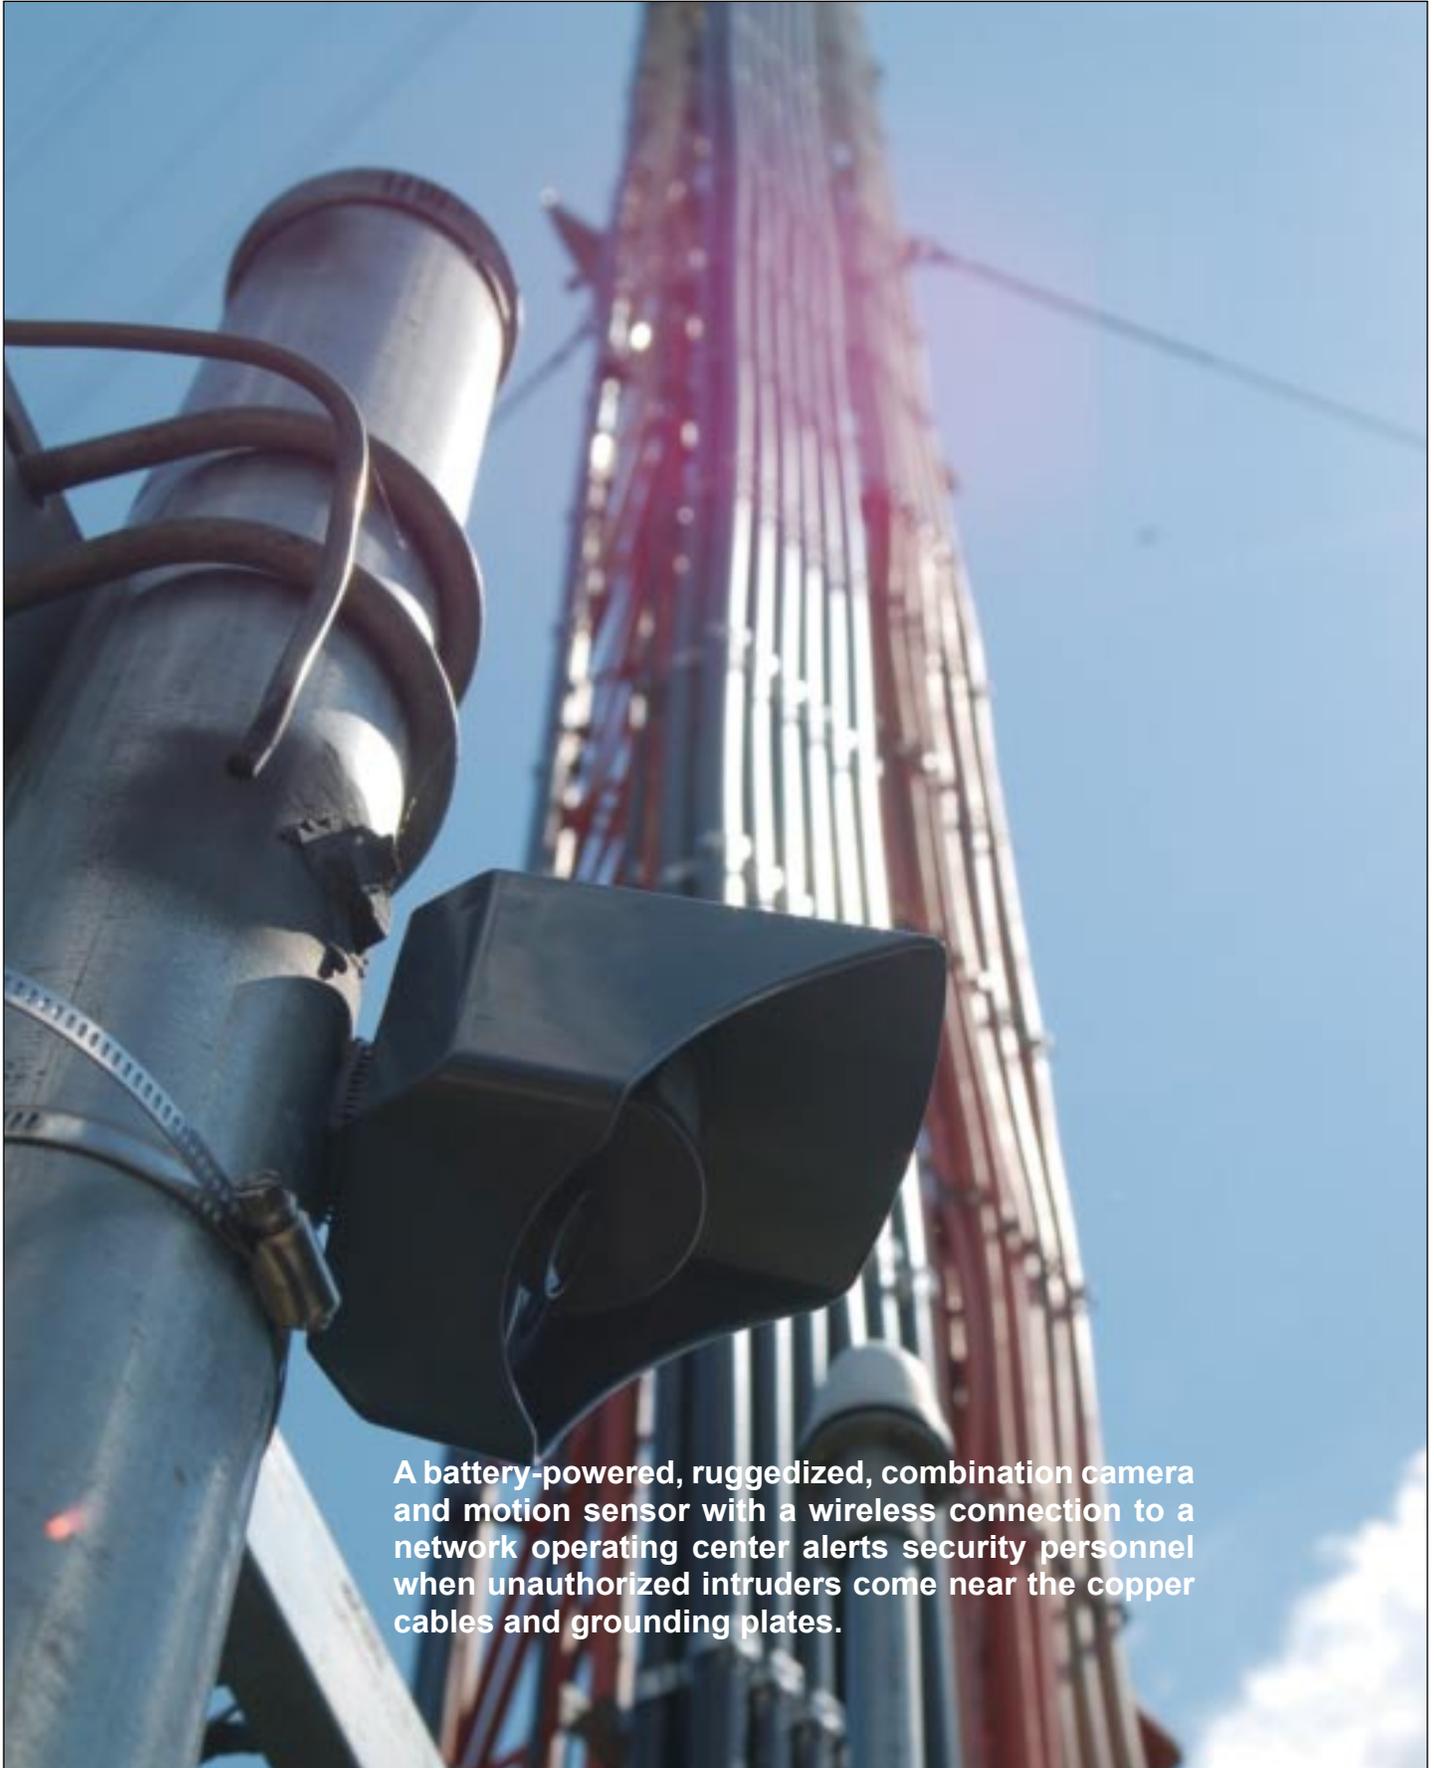
A battery-powered, ruggedized, combination camera and motion sensor with a wireless connection to a network operating center alerts security personnel when unauthorized intruders come near the copper cables and grounding plates.

To begin, SNC mounted the standard indoor Videofied camera and sensor combination in an irrigation valve box and put the entire assembly on a movable arm to create a "bucket cam" — the first outdoor Videofied camera. These early camera and sensor combinations became the forerunners of a new line of ruggedized outdoor devices.

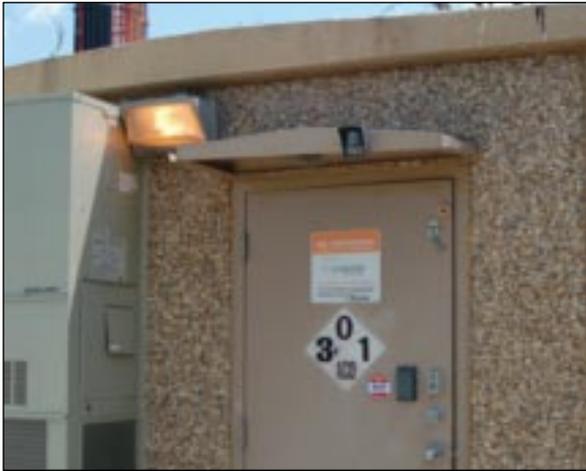
This view of a shelter shows the camera above the door and a proximity card reader on the door above the doorknob. The camera also views any approach to the air conditioner. Some thieves have removed air conditioners to gain entry to the building and have stolen all or part of the air conditioners for the metal they contain.

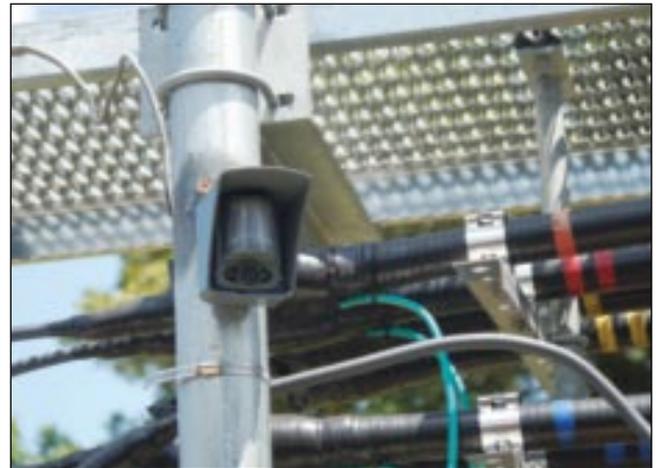
This camera gives a straight view from the cable tray looking outward, revealing any possible intruders to viewers at the security monitoring center. Metal thieves might be attracted by the copper in the wires shown here covered with green insulation.
